EASYklean

Technical handbook for the post weld treatment of stainless steel

**An easy to read and follow technical handbook which
summarizes various collaborative reports and studies from
leading Universities and materials testing companies**

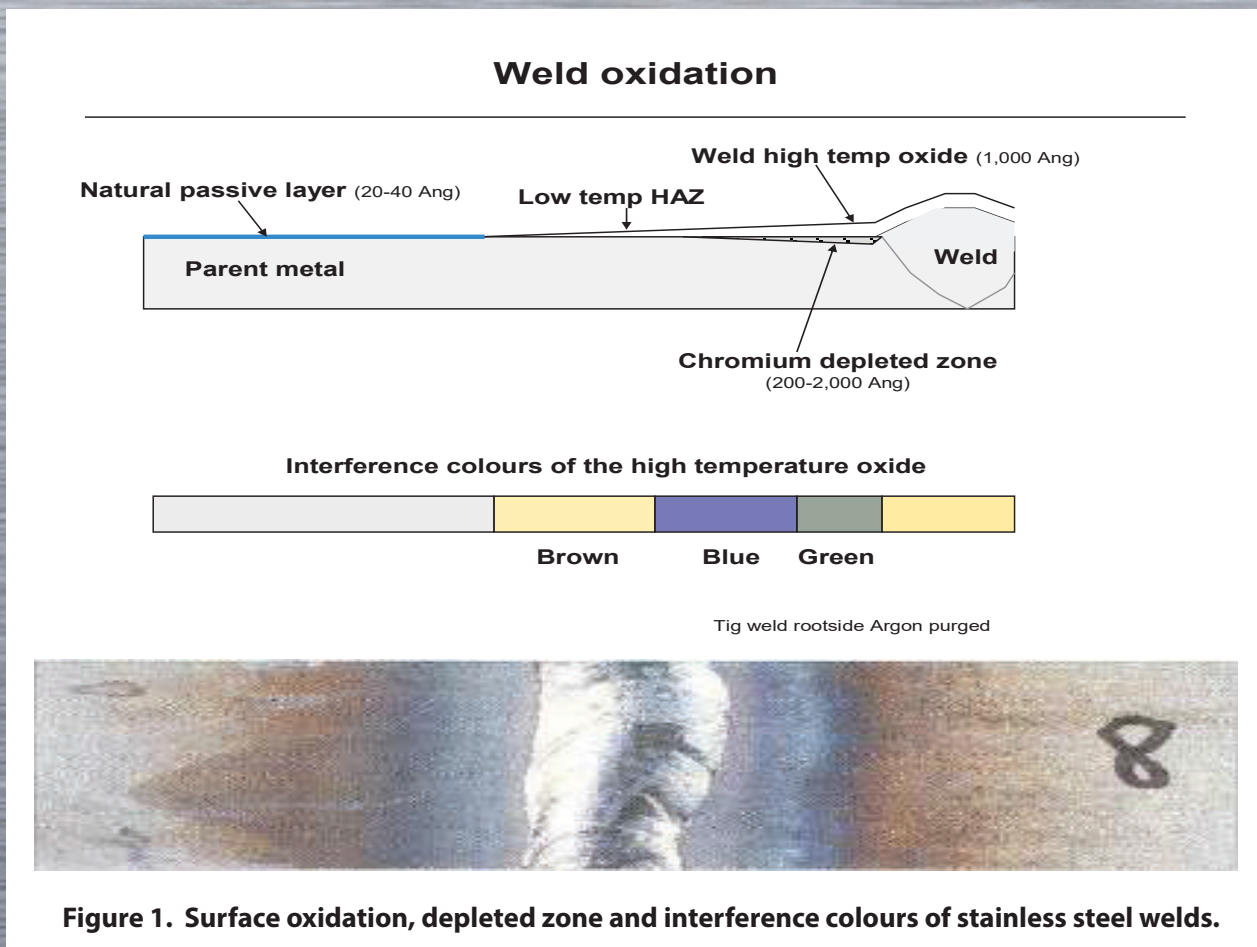
When stainless steel is welded, the high temperature heat affected zones (HAZ) are the result of chromium depletion at the surface through chromium carbide precipitation (Cr_{23}C_6). The stainless steel within this chromium depleted area or zone is left with diminished or no protection from corrosion. The surface oxidation and chromium depleted zone, along with interference colours caused by metal oxides are represented in Figure 1.

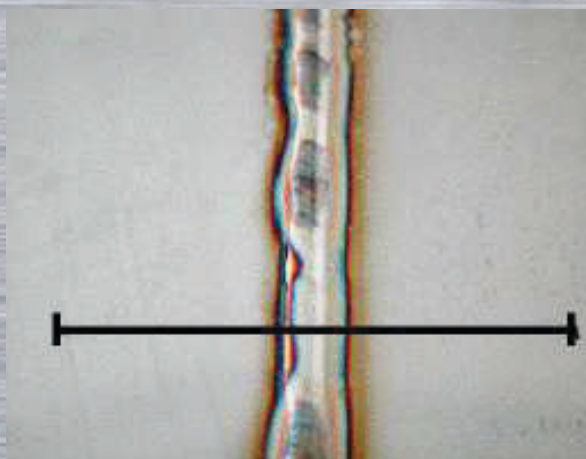
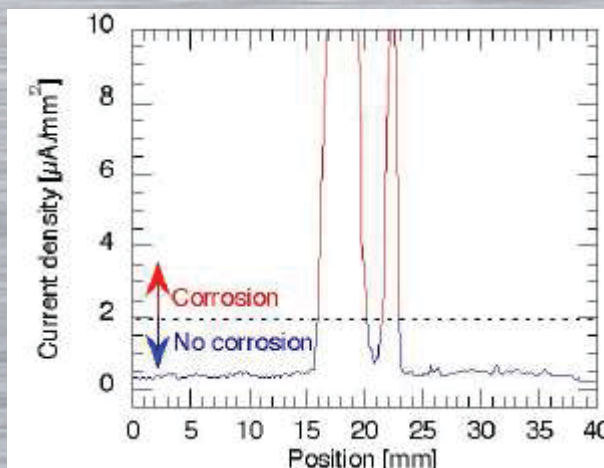
Fig. 2 : Potentiostatic line scan over a weld in a 304 stainless steel test piece showing the variation in corrosion current.

In Figure 2 a porous tip is positioned on the surface of the sample through which a salt electrolyte (0.1 M NaCl) is allowed to flow whilst a control unit holds the tip at a constant 260 mV as it measures the current flow to the sample. The tip size is 1.5 mm².

Significant increases in current are seen as the tip passes over the weld, indicating that these regions are much more susceptible to corrosion than the parent metal.

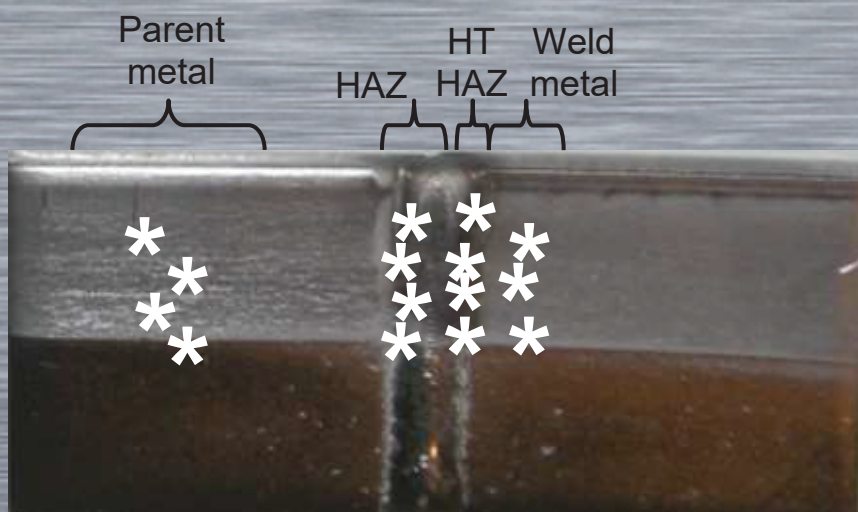
Figure 3. Location of Pitting Potential measurements

Pitting potential measurements were made on the parent metal, the heat affected zone (HAZ) within 4mm of the weld fusion boundary, the high temperature heat affected zone (HTHAZ) at the fusion boundary and on the weld metal of each sample (Figure 3). The results show the pitting potential as a value in mV; the maximum value of potential obtainable by the test instrument was 737mV. The test method is quite sensitive to defects such as oxidized welds and inclusions etc.

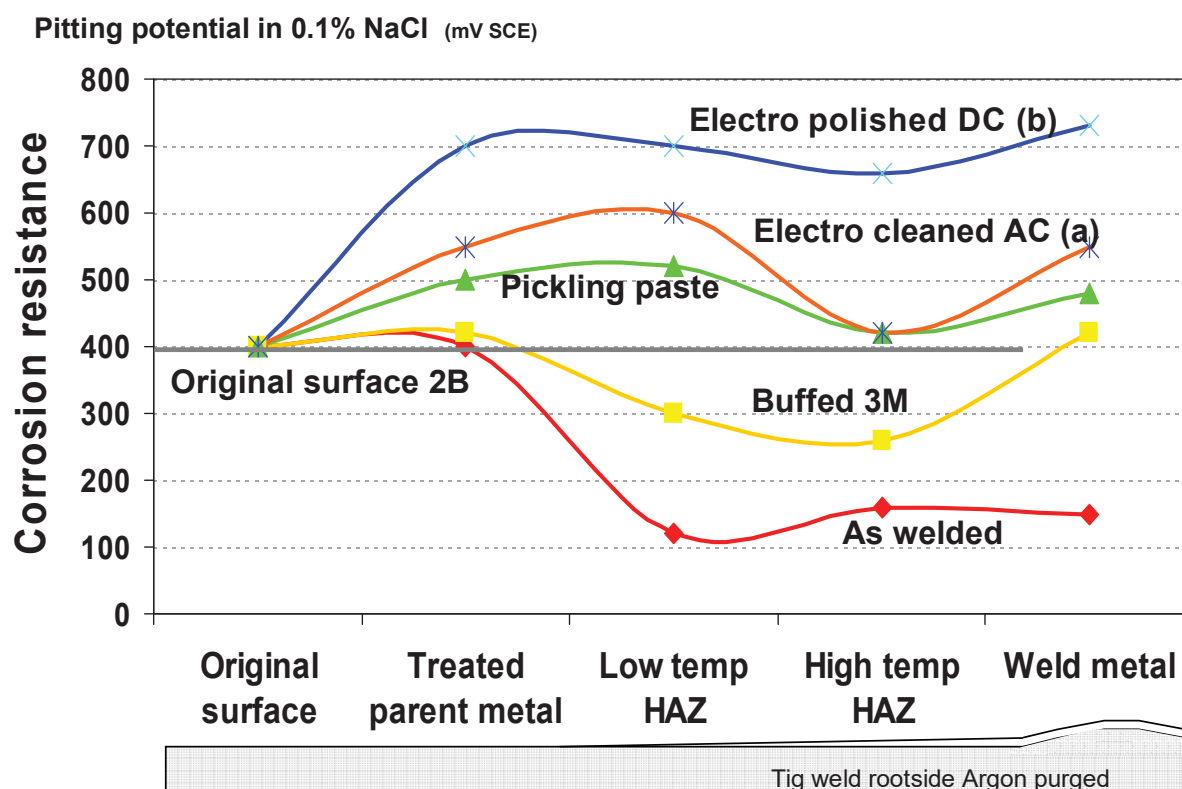
Figure 4. Effect of cleaning methods on a stainless steel weldment.

These results are summarized in the following graph in Figure 4.

The two test methods employed to evaluate the effect of surface treatments on the pitting corrosion resistance of weldments produced similar results. These tests confirmed that all cleaning methods improve the corrosion resistance of the weldments, however mechanical abrasion has the least positive effect. The standard method used for cleaning weldments with pickling paste showed positive results, however it did not return the surface to the same level of corrosion resistance as the parent metal in the high temperature heat affected zone. The largest improvement in corrosion resistance was demonstrated by the mepBLITz with the carbon fiber brush, which exceeded the performance of the pickling paste and returned the overall corrosion resistance of the entire weldment close to and in some areas exceeding that of the parent metal.

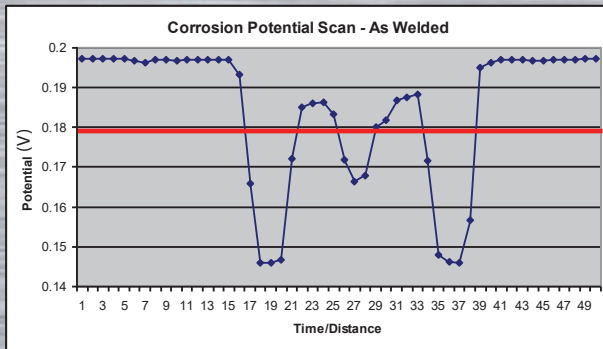
Fig. 5 - The as-welded 304 surface contains surface oxidation, which is susceptible to corrosion in the high temperature heat affected zone (HAZ). The heavy oxidation of the 316 weld metal also makes this region susceptible to pitting. Corrosion could be expected in both the HAZ and weldmetal.

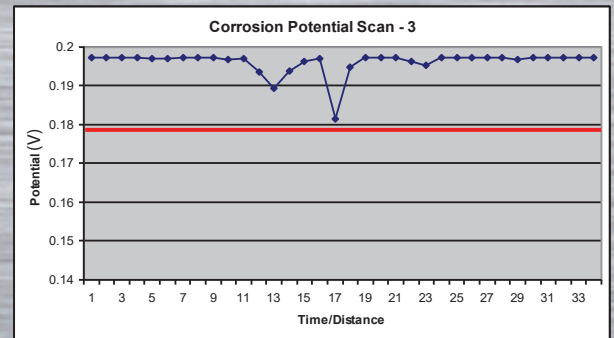
Fig. 6 - The mepBLITz with Carbon Fiber Brush and Acid has given excellent all round results. It is considered that this surface treatment would resist pitting corrosion across the entire weldment.

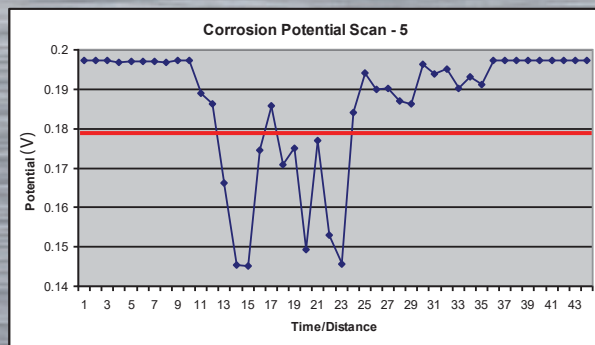
Fig. 7 - The 3M Brushed mechanical treatment gave very little improvement from the as welded sample. Pitting corrosion would be expected in the HAZ.

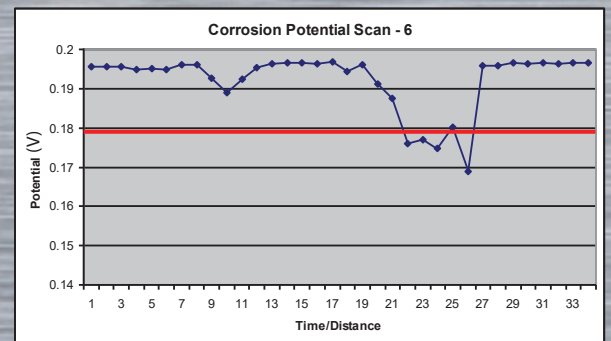
Fig. 8 - The Pickled finish gave good results however the results were inferior to the mepBLITz Carbon Fiber Brush treatments. The high temperature HAZ may be expected to suffer some pitting corrosion attack.

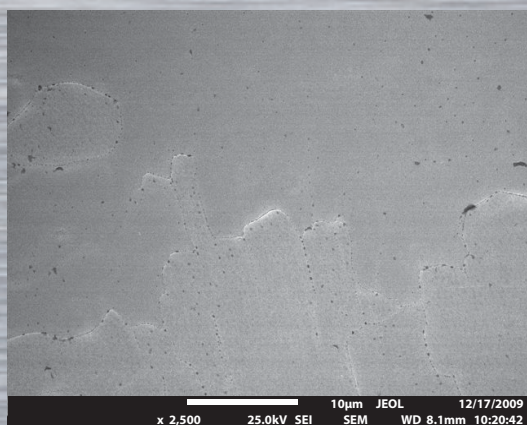
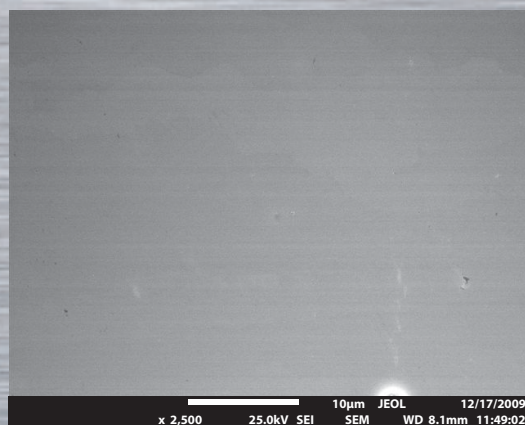
mepBLITz Electro-polisher

From the above "before and after", it is quite clear to see the smoothing effect that the portable DC weld electro-polisher (the mepBLITz in this case) has had on the weld. This effect from the electro-polishing process, preferentially removes any high points, which results in an extremely smooth finish that makes it difficult for foreign particles to adhere to the surface and drastically inhibits bacteria growth and foreign particle entrapment, giving maximum access to the oxygen required for a strong and continuous passive layer. Dramatically improving the corrosion resistance process.

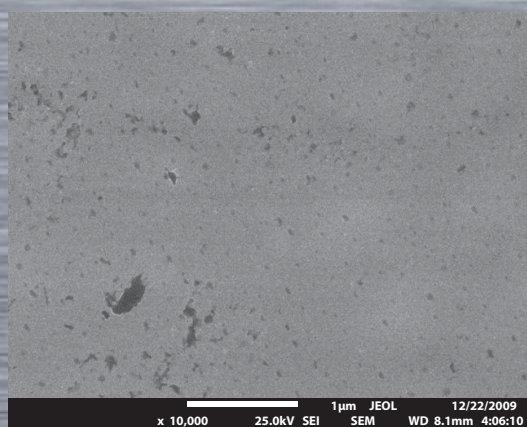
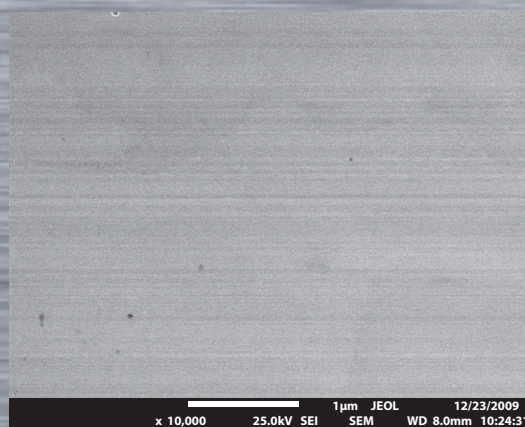
As with the above images of the mepBLITz, the EASYkleen Plus Brush machine, using once again a DC only output will improve the surface smoothness and receive the subsequent benefits. This smoothing effect, whilst removing a very small amount of material also aids in removal of large grain boundaries which are usual susceptible to pitting (corrosion).

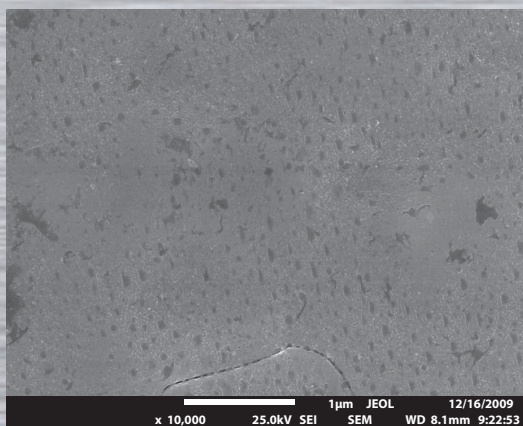
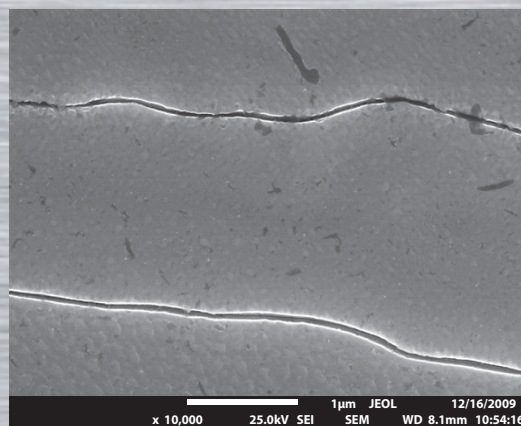
Pickling Paste

As mentioned in the Corrosion Resistance section of this booklet, pickling paste can restore some of the chromium which has been depleted from the welding process. However, it is unable to produce a smoothing effect like the electro-polishing process and will subsequently not provide the best possible corrosion resistance that can be achieved.

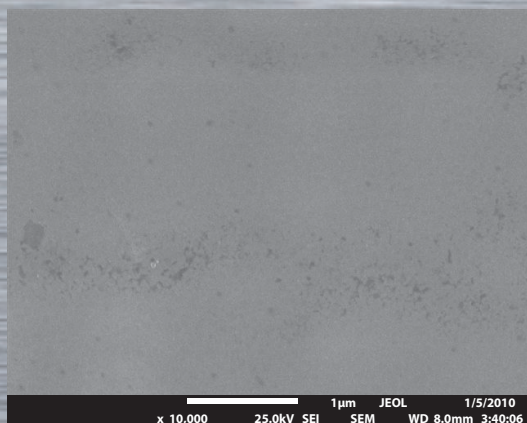
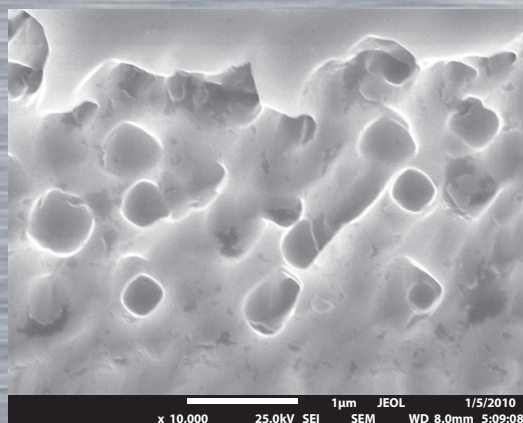
AC Weld Cleaning Machine

The difference between the AC untreated and treated weld is quite distinctive. Even though the weld discolouration may be removed when using an AC weld cleaning machine, when looking more closely you can see the rough finish that is produced.

This surface finish is very irregular which helps contaminants stick or attach to the surface, which increases the pitting potential (corrosion). With the current alternating and the use of a carbon fibre brush (in this case), particles are being removed and deposited in each direction, which in this case creates two problems.

Firstly, the carbon fibre electrode, whilst similar to the DC type, is actually being used up much faster because the current alternates from each side. Secondly, when the deposition is happening on the work piece side, there is a high potential for carbon fibre and the solution material to be deposited on the work piece. There is a large contamination potential during AC weld cleaning due to this effect. This is not however the case with a DC output machine, as particles are going in one direction only - Work piece to brush electrode.

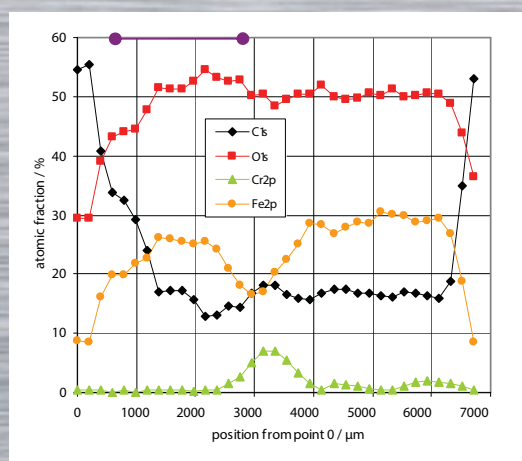
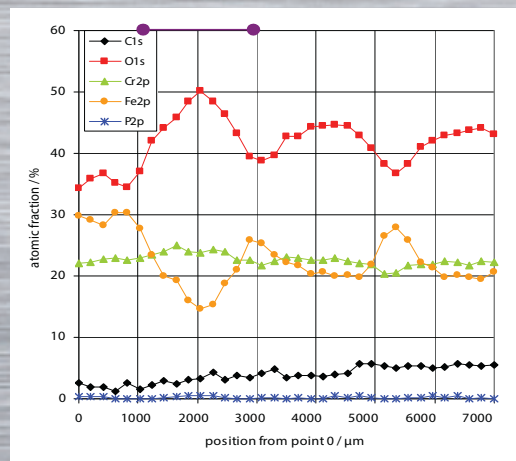
Fig. 3 - Etched

As shown in Figure 3, the data for the as-received sample again indicates the dominance of carbon and oxygen on the surface. Cr is apparent at around 5 atomic %. Etching the sample results in the removal of much of the carbon, with less left behind compared to Sample 1.

In this sample there is also evidence of carbide carbon - the carbon 1s peak has components at lower binding energy than the nominal hydrocarbon peak at 284.5 eV (Figure 4). This carbide peak intensity is essentially constant across the linescan. There is very little phosphorus left on the surface of this sample. Cr and O amounts appear to be correlated, and are both anti-correlated with the amount of Fe. Ni is present at around 4 atomic % and is correlated with Fe.

Figure 3: XPS linescans across the weld in Sample 2, represented as atomic fraction as a function of position, for both etched and un-etched analysis lines. The weld is found between points 5 (1000 Åμm) and 14 (2800 Åμm), as indicated by the purple lines.

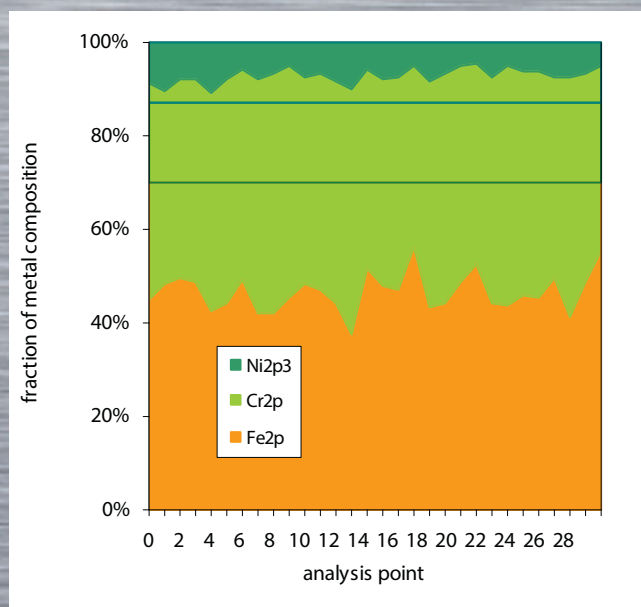
Fig. 11

Figure 11: Relative fractions of major metals as a function of position along Sample 6 (parent metal). Lines mark the expected fractions for the bulk metal (13% Ni, 17% Cr and 70% Fe).

Consistent with many studies on stainless steel surfaces, there is a significant enrichment of Cr at the sample surface compared to the bulk composition.

316 alloy contains around 10-14% Ni, 16-18% Cr, and 2-3% Mo. Minor constituents are Mn (< 2%), Si (< 1%), C (< 0.1%) and P (< 0.05%). The data for the parent metal (Figure 7) can be recalculated to include only the major metallic elements (Fe, Cr, Ni), and the results are shown in Figure 11 below.

Similar plots to Figure 11 can be made for all of the other samples analyzed so far.

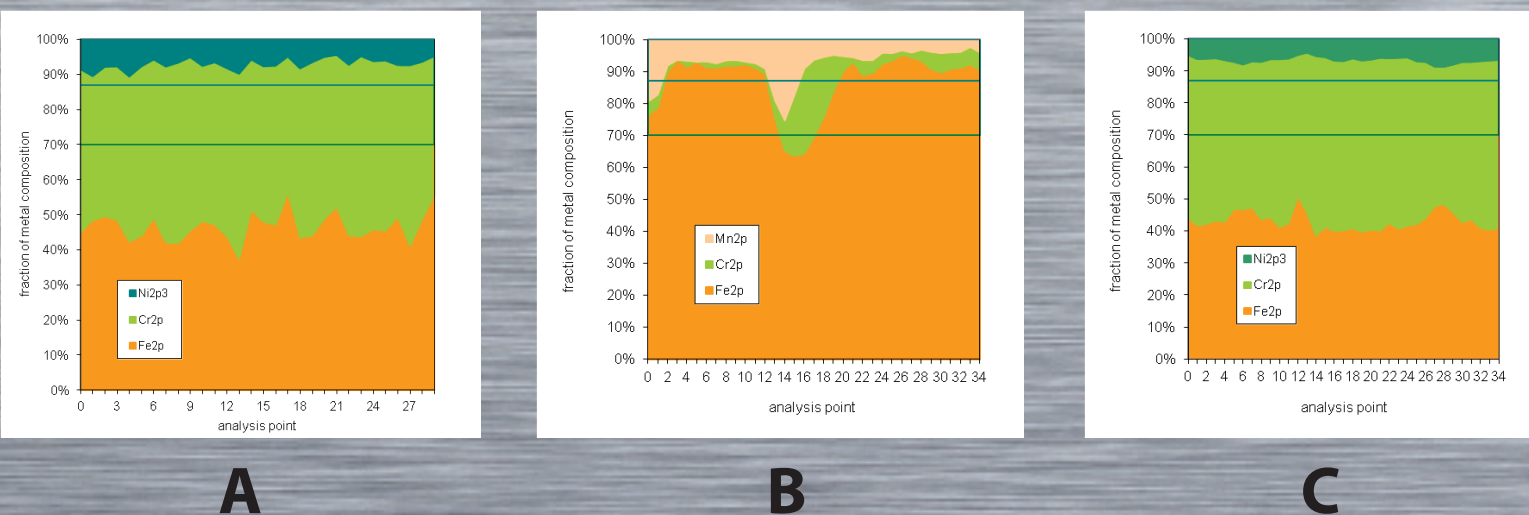
Figure 1A below illustrates the results of an XPS analysis of the surface of the steel prior to welding. This demonstrates that, as a fraction of the metals present on the surface, there is much more chromium present than there is in the bulk of the sample. The XPS data are also consistent with this being present in the form of chrome oxide.

Figure 1B represents the XPS analysis of an untreated welded sample. In this case the surface is almost all iron and manganese, with very little chromium present, which in part explains the poor corrosion resistance seen in such samples.

Figure 1C illustrates the XPS analysis of a welded coupon treated using the mepBLITZ and electrolyte B-30. Despite the presence of the weld, this sample looks almost identical to the parent metal (Figure 1A), indicating that this treatment has restored the protective chromium oxide layer on the metal surface.

Figure 1: Metal fractions at the surface of 316 samples determined using XPS analysis. A: Parent metal coupon, B. welded coupon, and C. welded coupon after treatment using the mepBLITz process. Horizontal lines indicate the composition of iron (Fe), chrome (Cr) and nickel (Ni) in bulk 316. Shaded areas in B and C represent the position of the welds.
